Technical Bulletin

Troubleshooting the AW55-50SN family

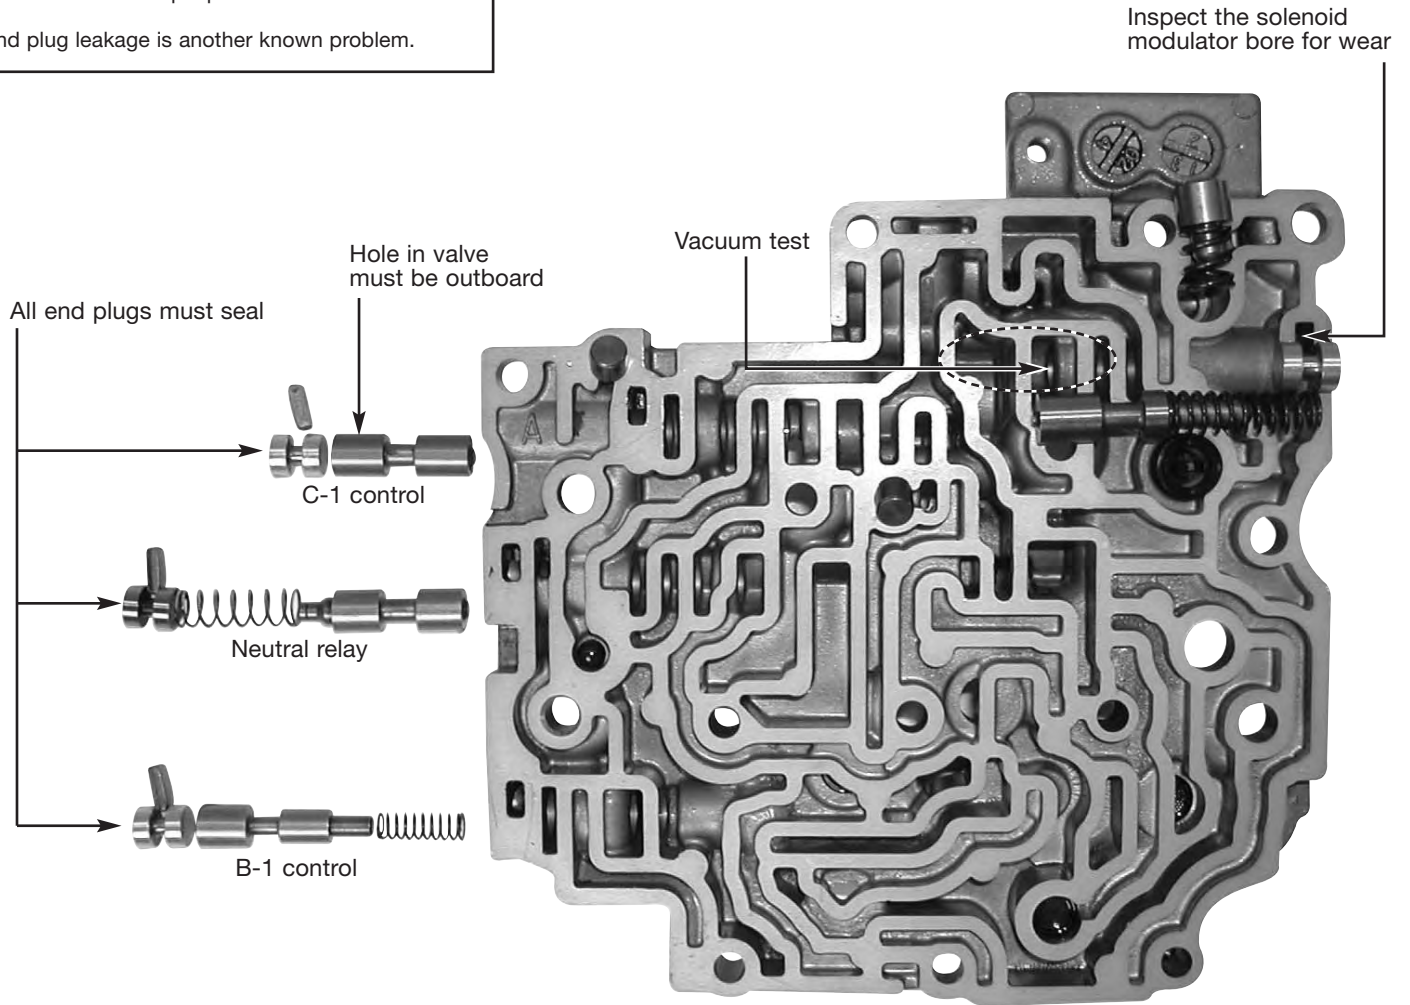
Figure 1

Front Control Valve Body

Solenoid modulator valve circuit testing is critical.

The modulator is very active and commonly worn.

Wear here affects pressure feed to all the linear solenoids and multiple problems can result.

End plug leakage is another known problem.

In the pictures that follow*, visual inspection of the bores can be made in the areas shown as ovals or circles. Vacuum or Wet Air tests are performed at the arrows.
